Effective Sealing of Pavement Cracks in Cold Urban Environments

J-F. Masson, Ph.D.

Published by
Institute for Research in Construction
National Research Council of Canada
Ottawa, Canada, K1A 0R6

©National Research Council of Canada
August 1997
ISBN 0-660-17091-4
NRCC 41098

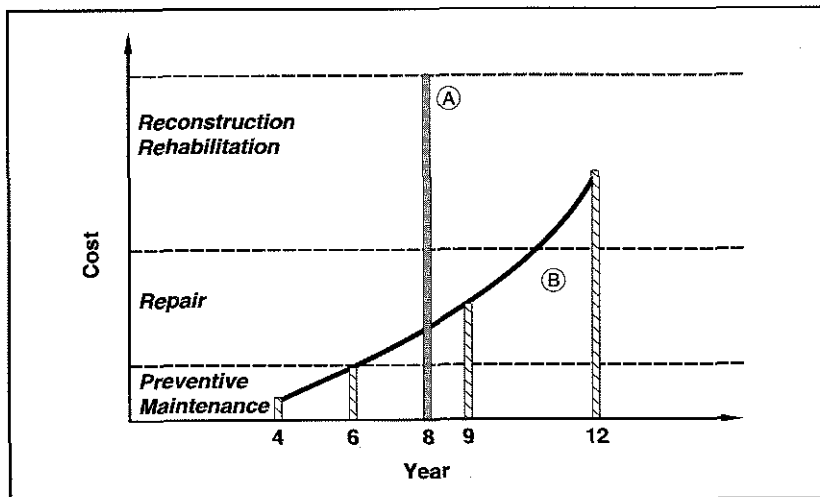
Figure 1. Preventive maintenance, such as crack sealing, allows for delaying pavement degradation. The periodic sealing of cracks after 4 and 6 years and patching at 9 years, for example, can delay the more costly rehabilitation work until the 12th year (B). The frequency of major rehabilitation or reconstruction, and the cost thus remains below that incurred without maintenance work (A).

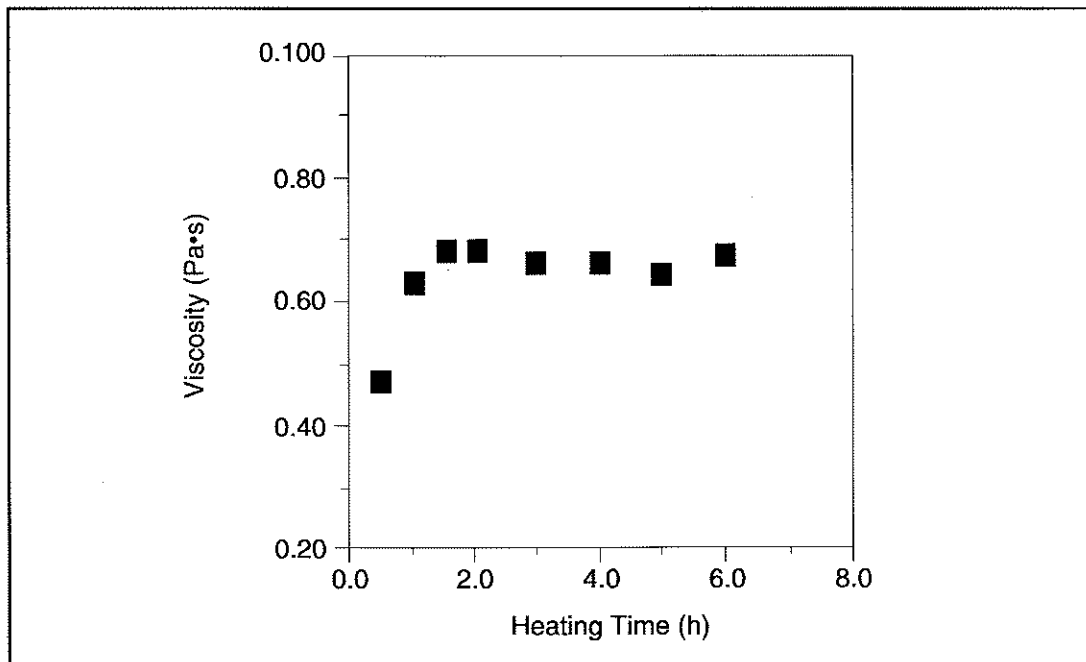
Figure 4. The shear viscosity of a 300/400 penetration grade bitumen at 185°C

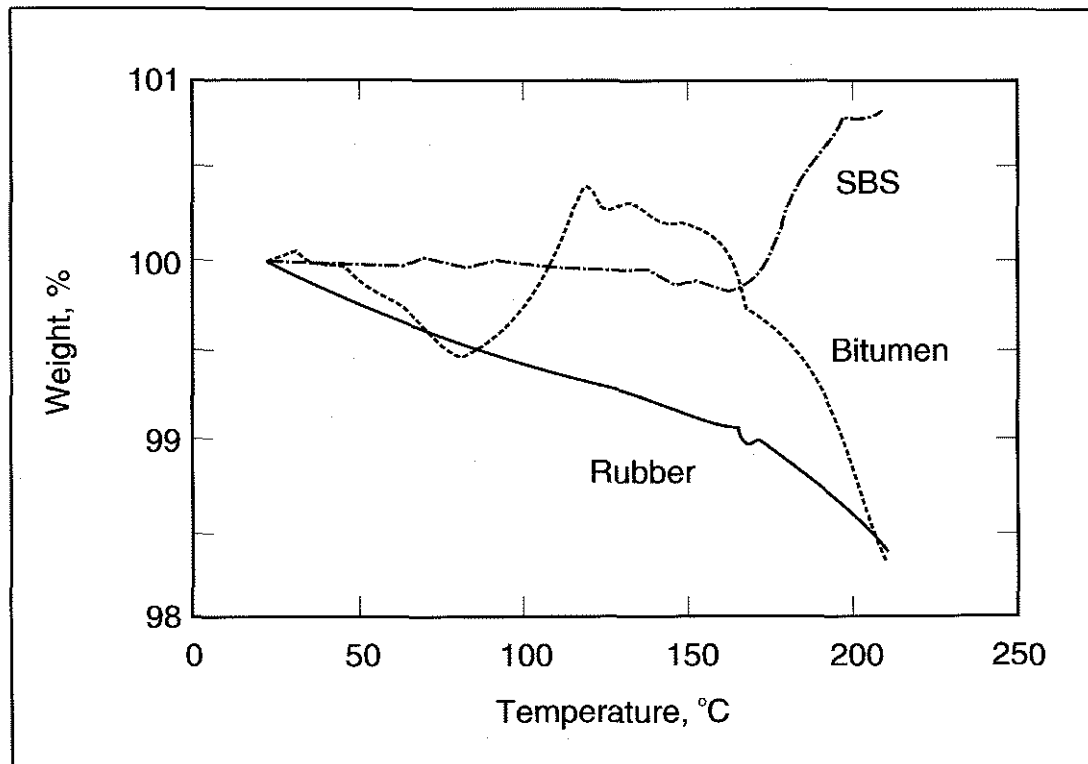
Figure 6. Typical weight change of representative sealant raw materials during heating in air at 5°C/min as measured by thermogravimetry. The weight of the SBS copolymer remains constant until about 170°C and then increases because of its gain in oxygen, i.e., oxidation. In contrast, the recycled powder loses weight as process oils gradually volatilize. Bitumen shows a combined weight loss due to the volatilization of light oils and a weight gain due to oxidation.

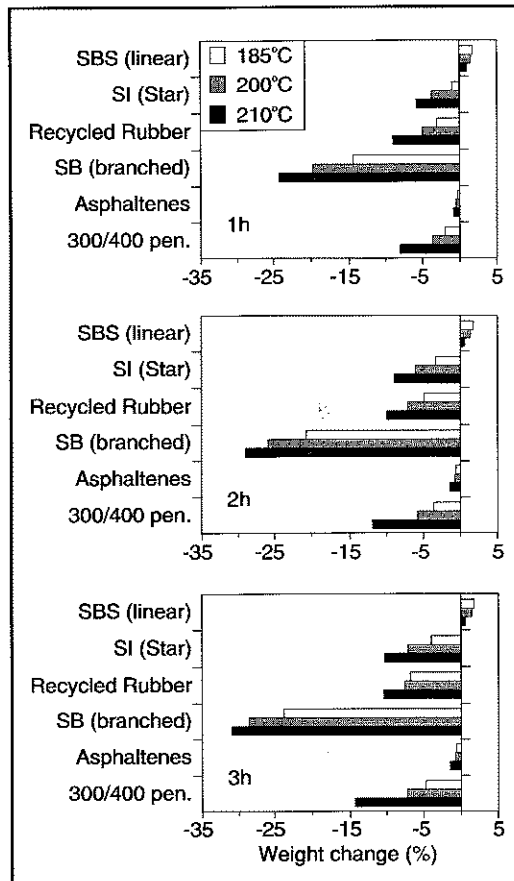
Figure 7. After rapid heating to temperatures representative of those found during sealant installation, raw materials were kept isothermally at those temperatures. All materials, but SBS, showed an increasing weight loss with time and temperature as measured by thermogravimetry.

Bitumen and elastomers — the main components of sealants — are made of compounds containing mostly carbon, hydrogen, oxygen and nitrogen. Consequently, bitumen and elastomers may oxidize, degrade, or lose volatile components when heated (see Figure 6). Representative raw materials may lose more than 15% in weight when kept at 210°C for 1 hour (see Figure 7).

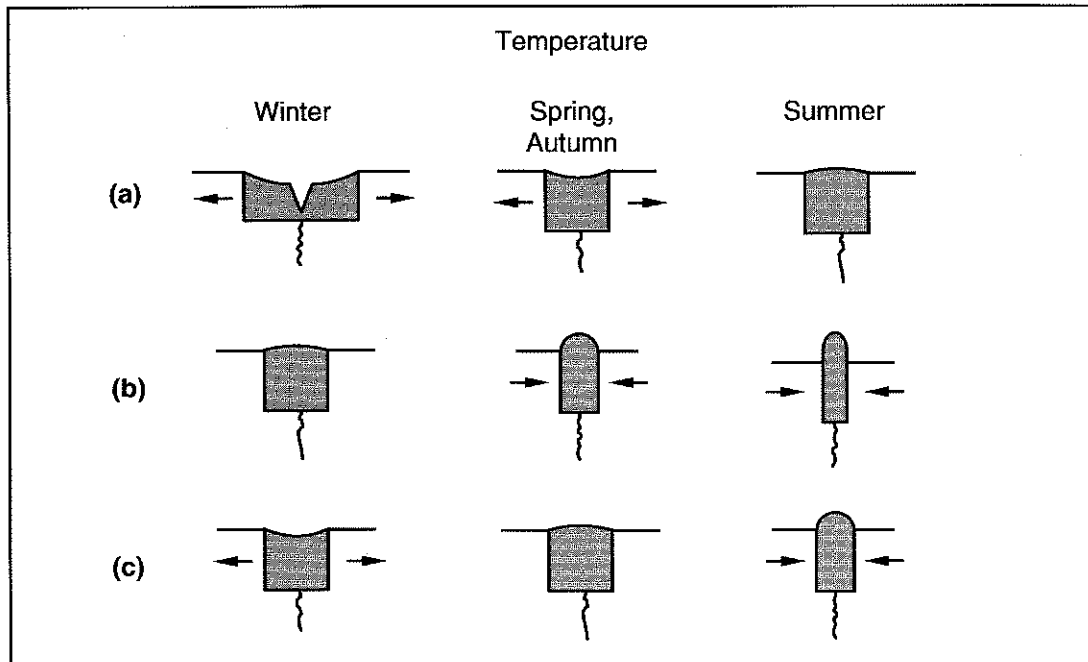
Figure 12. Potential effects of seasonal cycles on crack repairs carried out in summer (a), winter (b), and spring and autumn (c)

Crack sealing should be conducted at a time of year when the temperatures are moderately cool, i.e., in the spring or fall. It is not uncommon, however, to observe crack-sealing operations during the summer months. Working conditions are pleasant and cracks have dried out. There is no doubt that sealant performance is very dependent upon proper and consistent workmanship during both crack preparation and sealing operation, and that good workmanship is most likely to be achieved during good conditions. Unfortunately, if cracks are sealed in the warmest period, the resulting seal will be in constant extension, thus increasing the chances of seal failure (see Figure 12). If cracks are sealed

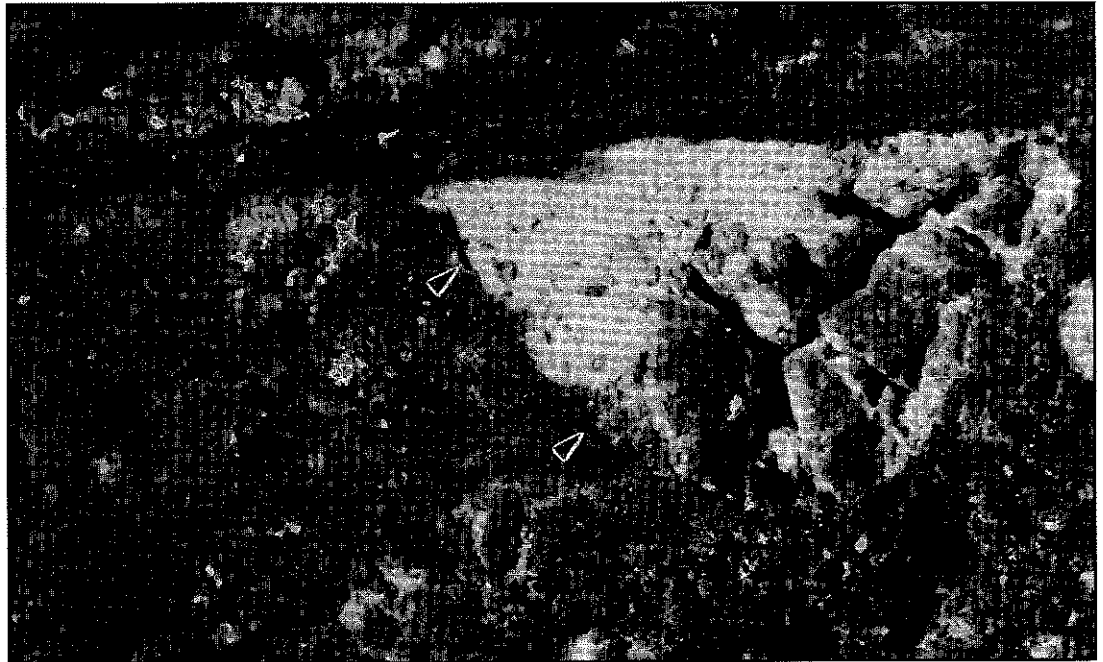
Figure 13. Magnified (6X) top view of an aggregate at the bottom of a rut. The use of the impact router has caused aggregate to shatter and debond from the bituminous binder (arrows).

at the bitumen/aggregate interface and within aggregates themselves (see Figures 13 and 14). Micro-cracks propagate upon freezing and thawing and reduce the strength of the AC. They constitute defects at the sealant/AC interface where they can enhance debonding. A magnified view of the sealant-AC interface shows how this can occur (see Figure 15). As the sealant pulls on the aggregate during winter months (either because of thermal or traffic-related stresses), the cracked aggregate fractures further so that crystallites are left attached to the sealant. The bond between the sealant and the AC is thus broken. Alternatively, an entire aggregate may be pulled out of its bed by a sealant (see Figure 16). Seal failure is, in these instances, not caused by a debonding of the sealant, but by a loss of cohesion in the AC close to the surface of the rout. The frequency and the exact conditions leading to this type of failure remain to be investigated.

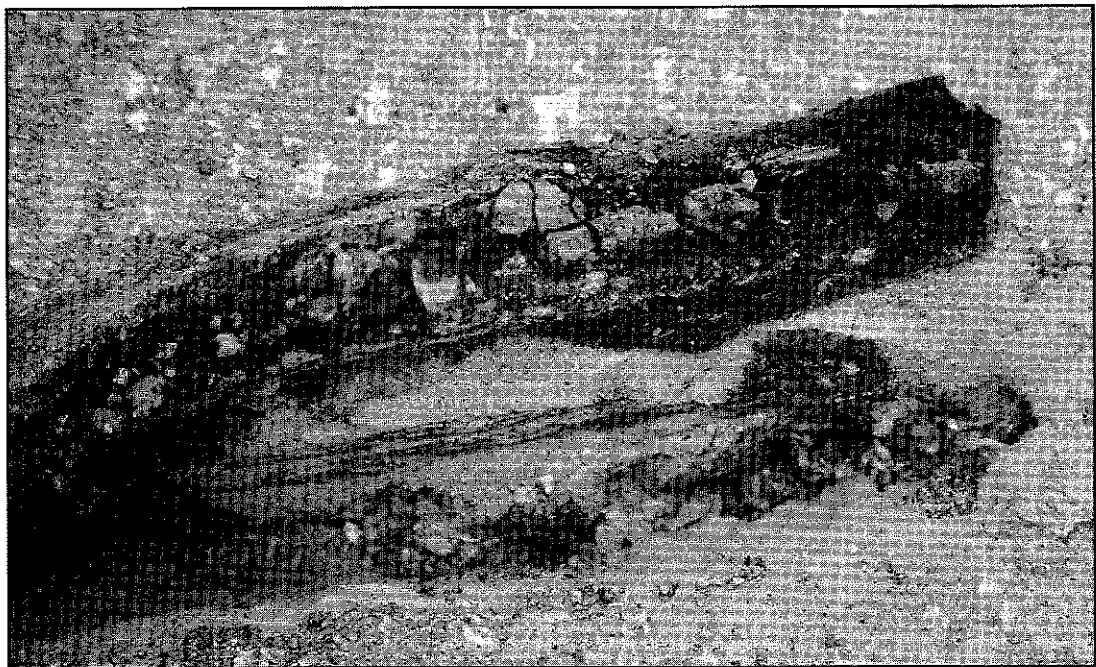
Figure 16. After micro-cracks have appeared at the aggregate-bituminous binder interface, aggregates can be pulled out of their bed by a strongly adhering sealant.

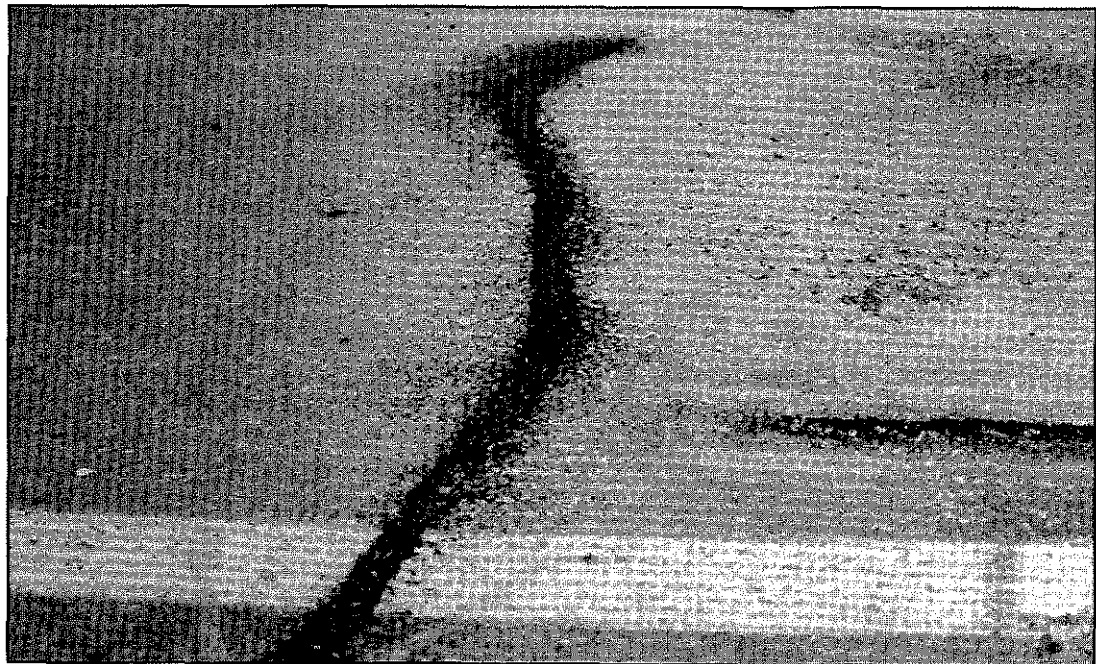
Figure 18. Typical blackening of an overheated rout
